Waterproof Nontoxic Rose Red Car Paint , Glossy Automotive Refinishing Products

Meklon Rose Red Car Paint High Gloss Even Hot Selling Customized

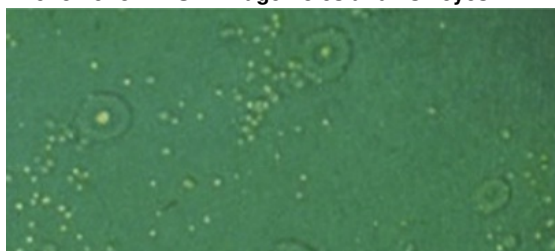
Phenomenon 2: Shrinkage holes and fish eyes:

The surface of the object to be coated has not been cleaned and exists, or due to the influence of foreign matter (such as oil, water, silicon steel, boron, etc.) mixed into the paint, the paint cannot adhere evenly and shrinks to expose the coated surface, or the primer is not treated properly. The phenomenon of uneven paint caused by the presence of tiny blisters is called shrinkage cavity coating film problem. Remedy: If the shrinkage cavity is not serious, you can spray two more coats to add anti-cavities when the paint surface has just reached its normal evaporation time. If the paint is caused by beads of water, if the situation is serious, the affected area should be cleaned and then repainted.

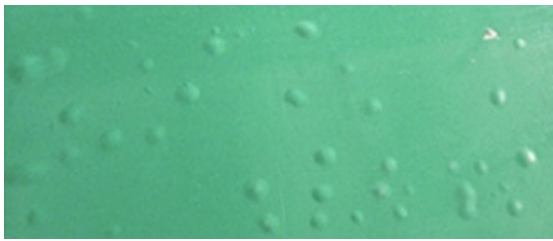
Phenomenon 4: Blistering and itching:

During the coating process, bubbles may appear on the surface of the coating film or bubbles may appear in the coating film. Remedy: Sand the coating until all solvent bubbles are removed, then spray again.
